# Malaysia Airlines Flight 370: Evaluation of Key INMARSAT / ATSB Assumptions

***MALAYSIA AIRLINES FLIGHT 370  
EVALUATION OF KEY INMARSAT / ATSB ASSUMPTIONS***

***Stuart S. Yeh  
University of Minnesota***

*May 2016*

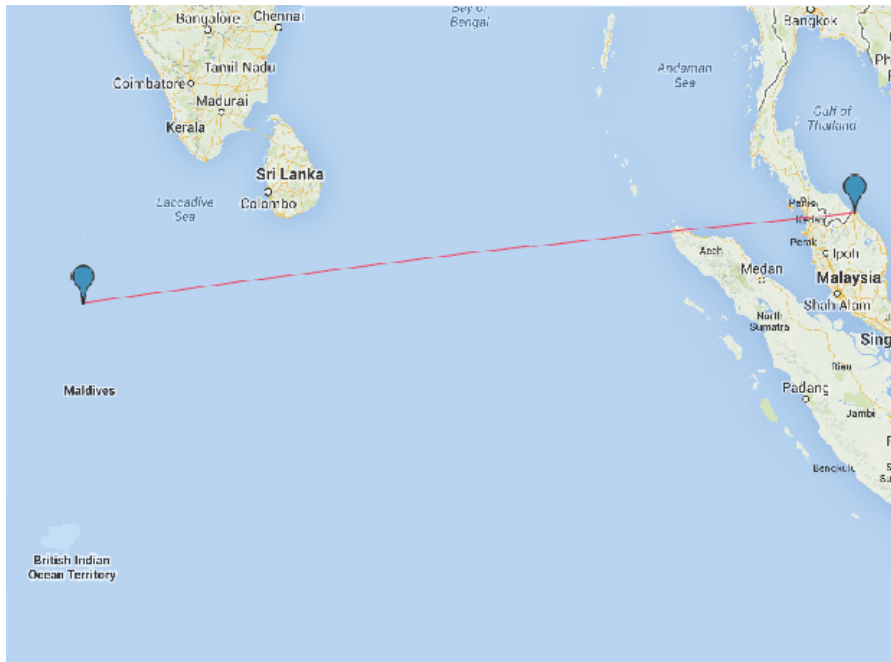
6:15 am local time is 9:15 am Malaysian time—8 hours and 34 minutes after takeoff, in other words, very near fuel exhaustion. If the report is accurate, MH 370 most likely crashed into the Indian Ocean southeast of Dhaal atoll in the Maldives (Figure 3). That is where the search should be concentrated.

Figure 3. Projected path of Malaysia Airlines 370 from Kota Bharu Malaysia to Dhaal Atoll in the Maldives

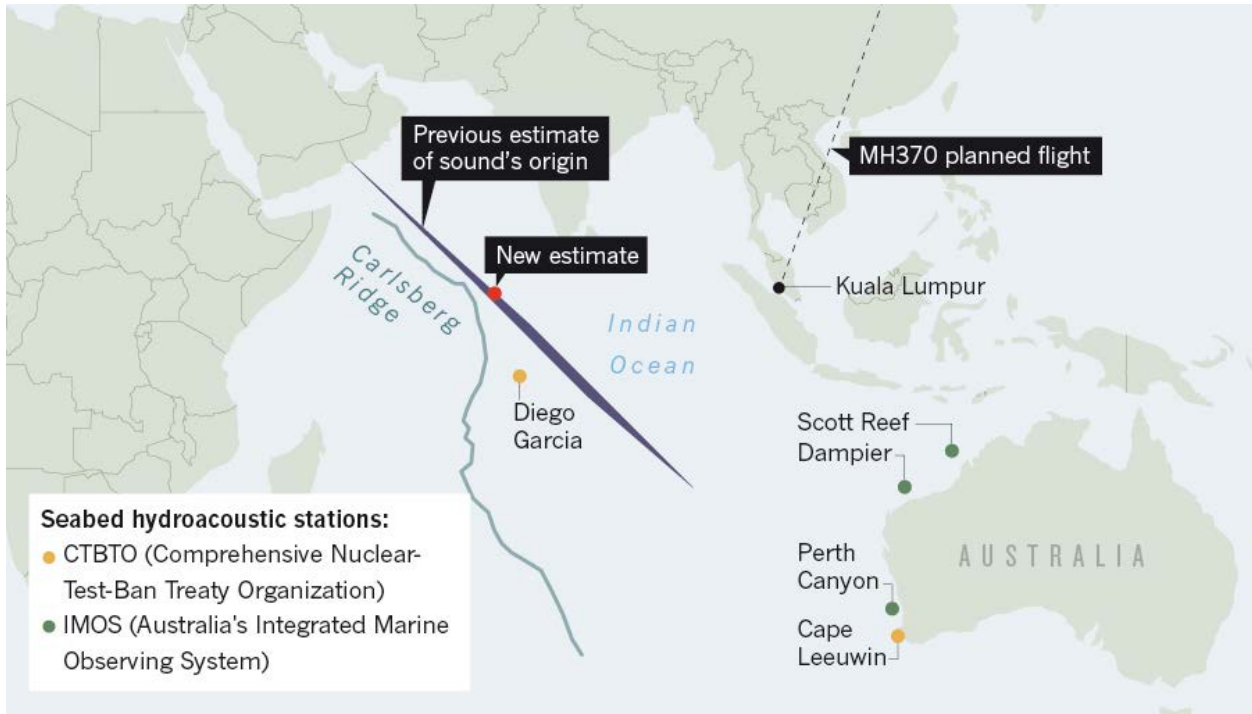
Australia. The new estimate places the source of the sound east of Carlsberg Ridge, remarkably close to the sighting of the unidentified aircraft over Dhaal atoll in the Maldives (Figure 4 and Figure 5).

Figure 4. Estimated geographic location of acoustic signal lies east of Carlsberg Ridge near Maldives

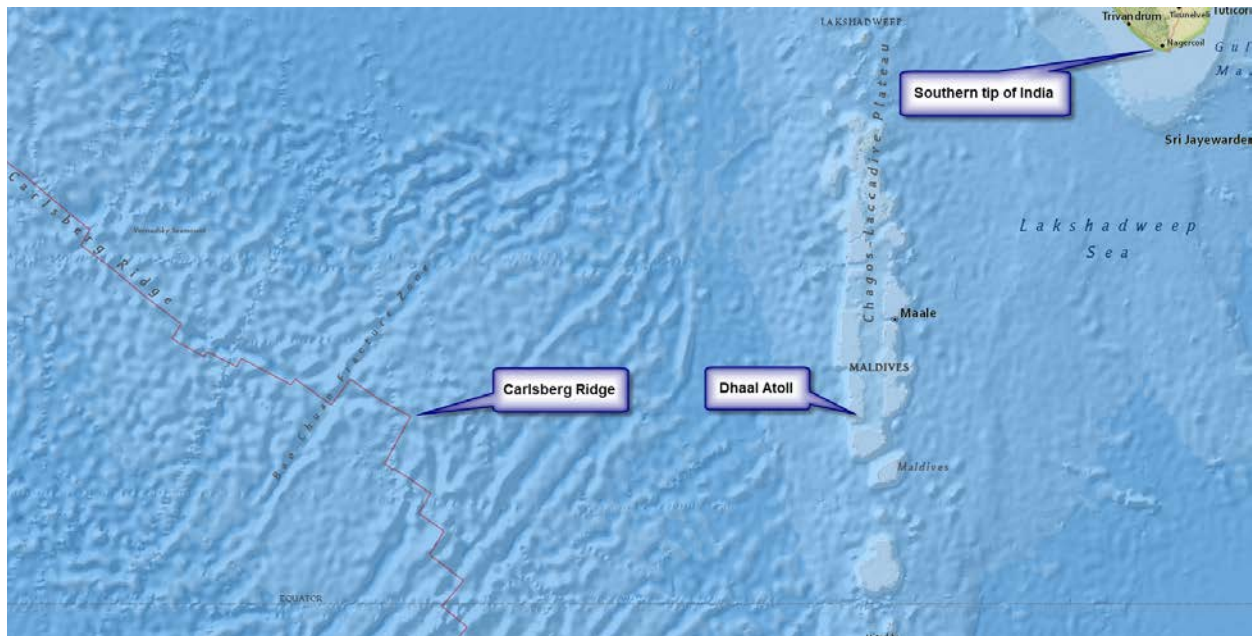
Figure 5. Dhaal atoll in the Maldives lies east of Carlsberg Ridge (see red line)

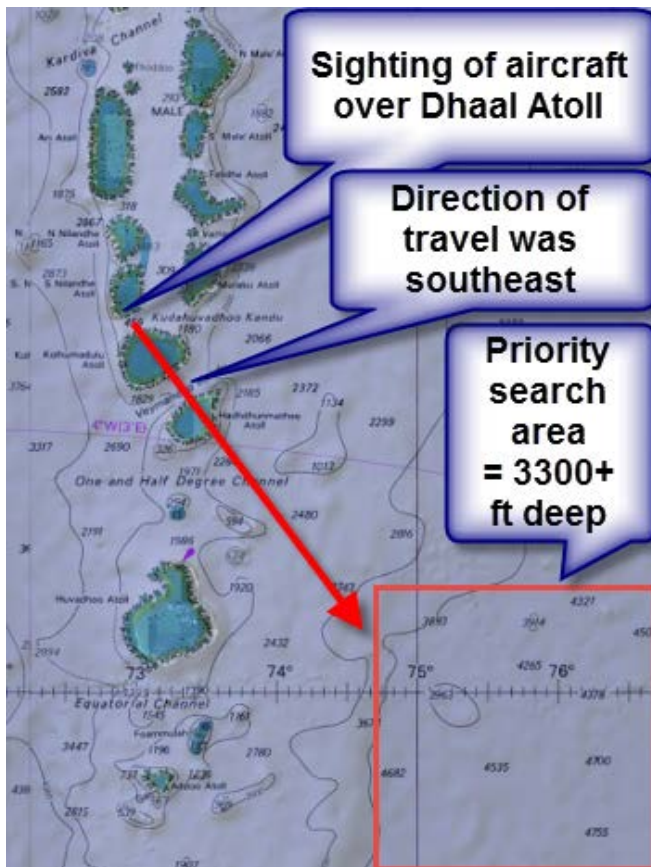
Alec Duncan, at Curtin University's Centre for Marine Science and Technology, stated that "if the sound [detected by two sets of underwater listening devices located off the west coast of Australia 20 minutes after the Dhaal atoll aircraft sighting on March 8] was generated by the implosion of some part of the aircraft as it sank ... at a depth of about 1000 meters, then the resulting sound would propagate effectively in the deep sound channel and could conceivably be detected at ranges of thousands of kilometers". This suggests that the search for MH370 should be concentrated in water that is a minimum of 1000 meters in depth. In sum, the priority search area should be water that is a minimum of 1000 meters in depth southeast of Dhaal atoll in the Maldives (Figure 6).

Figure 6. Priority search area southeast of Dhaal atoll in Maldives.

The current analysis suggests that search efforts should be redirected to the area southeast of Dhaal atoll in the Maldives. The aircraft was sighted 8 hours and 34 minutes after takeoff. Thus, it was very near fuel exhaustion and could not have traveled much further. If so, the search area would not be large. The towed underwater sonar device should be used to sweep this area in an effort to locate debris that presumably sank to the ocean floor. While some debris may have remained afloat and may eventually wash ashore on the east coast of Africa, the aircraft is a metal structure and, therefore, most of it would have sunk to the bottom of the ocean in the vicinity of the crash location, just as much of the debris from Air France 447 and the debris from TWA 800 was eventually located on the ocean floor.
