Malaysia Airlines Flight 370: Evaluation of Key INMARSAT / ATSB Assumptions

***Stuart S. Yeh
University of Minnesota***

May 2016

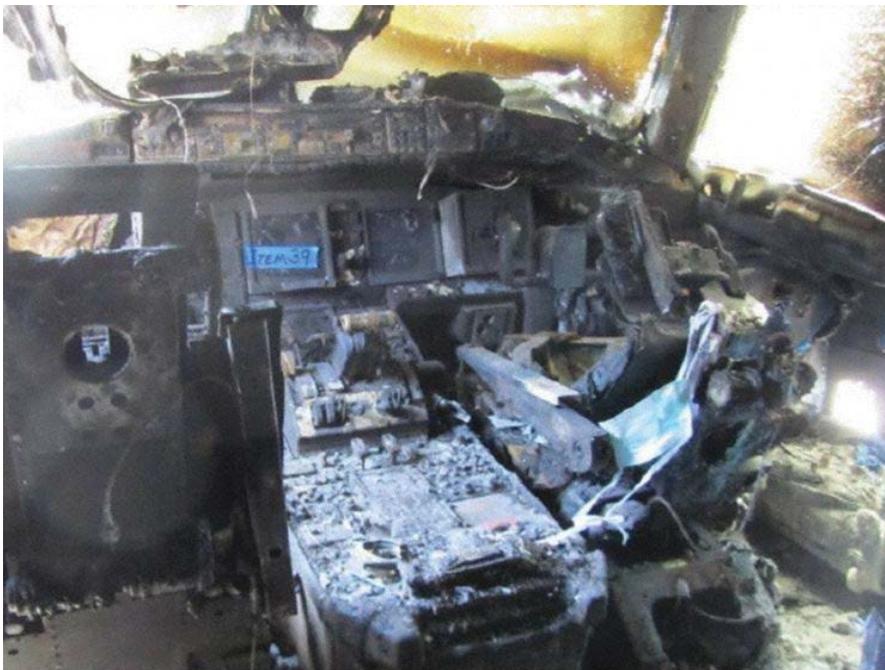
Figure 1. Electrical fire destroyed cockpit of EgyptAir 667

While the images of the EgyptAir 667 cockpit suggest major damage, the aircraft was on the ground when the cockpit oxygen hose ignited. The fire continued to be fed by air flowing freely into the cockpit. The fire was not extinguished through depressurization and was only extinguished with great difficulty.

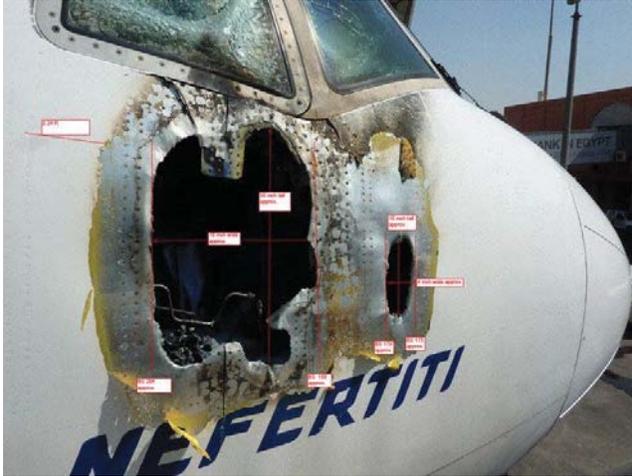
Figure 2. Fire burned through the skin of EgyptAir 667
