# Malaysia Airlines Flight 370: Evaluation of Key INMARSAT / ATSB Assumptions

***MALAYSIA AIRLINES FLIGHT 370  
EVALUATION OF KEY INMARSAT / ATSB ASSUMPTIONS***

***Stuart S. Yeh  
University of Minnesota***

*May 2016*

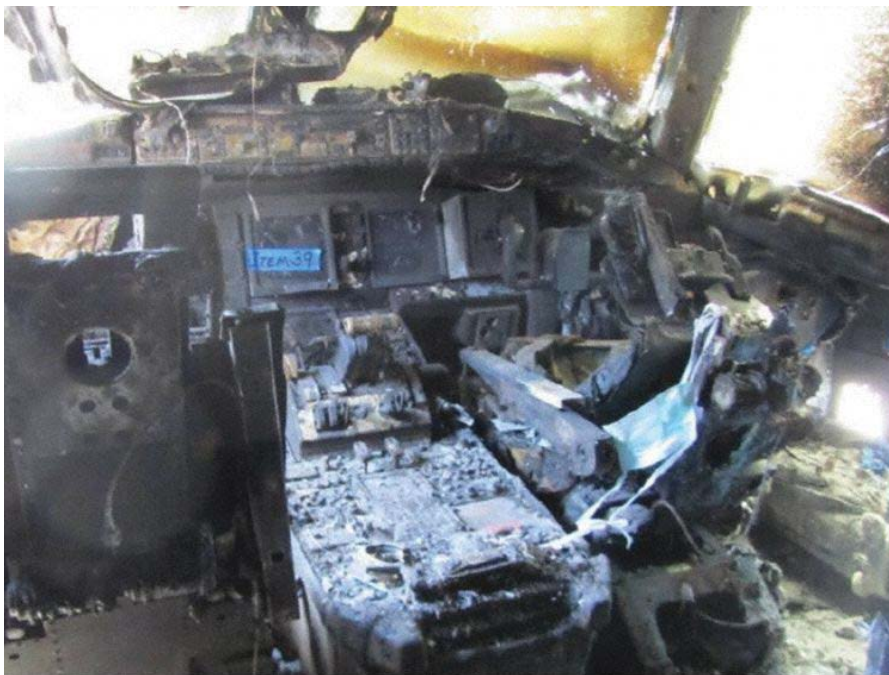
Figure 1. Electrical fire destroyed cockpit of EgyptAir 667

While the images of the EgyptAir 667 cockpit suggest major damage, the aircraft was on the ground when the cockpit oxygen hose ignited. The fire continued to be fed by air flowing freely into the cockpit. The fire was not extinguished through depressurization and was only extinguished with great difficulty.

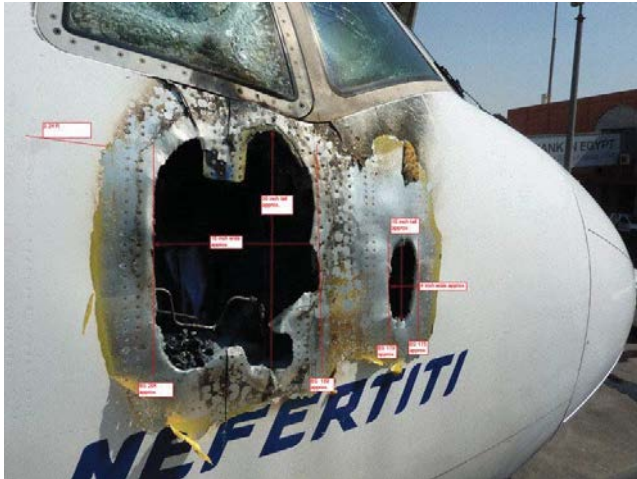
Figure 2. Fire burned through the skin of EgyptAir 667
