# Case Study of the Replacement of Corrugated Metal Culverts Using Pipe Bursting,

**North American Society for Trenchless Technology (NASTT)  
NASTT's 2016 No-Dig Show**

**Case Study of the Replacement of Corrugated Metal Pipe (CMP) Culverts using Pipe Bursting**

Simon Asinor Adamtey, Bowling Green State University, Bowling Green, Ohio  
Lameck Mairura Onsarigo, Bowling Green State University, Bowling Green, Ohio  
Alan Atalah, Bowling Green State University, Bowling Green, Ohio

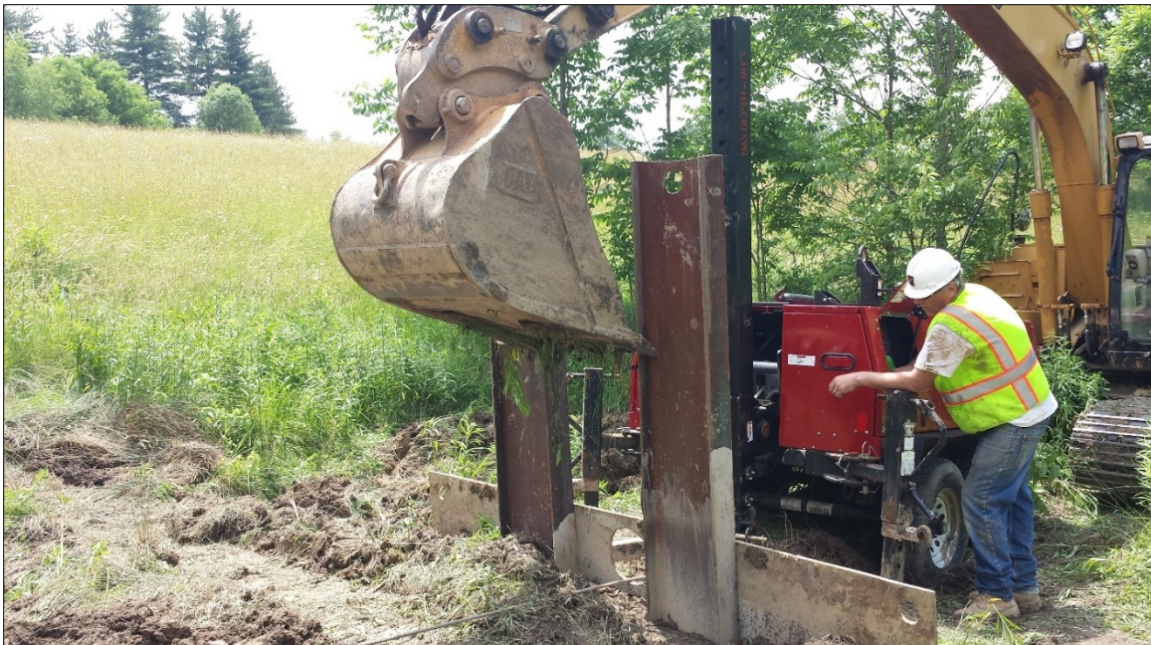
Figure 5: Setup with excavator supporting the I beams and steel plate

The steel plate was offset (by about 20 feet) from the existing culvert in the pulling pit to allow enough room for the pilot and expander to fully exit the existing pipe. The I-beams were driven into the ground behind the steel plate offering a surface for the winch to thrust against. However, because of this setting there was insufficient soil behind the steel plate to create the needed passive resistance. During bursting, the pulling force from the winch forced the I-beams and steel plate to tilt out of position. The steel plate and the I-beams were driven further into the ground to provide extra stability and held back by the excavator for additional support as shown in Figure 5. The entire culvert replacement work including setup and bursting took 10 hours. The actual bursting (installation) operation took 2 hours 20 minutes. The rate of burst was about 2 minutes per foot of pipe installed. The maximum pulling force from the winch was 12 tons and the air pressure from the compressor averaged 1000 psi for the burst.

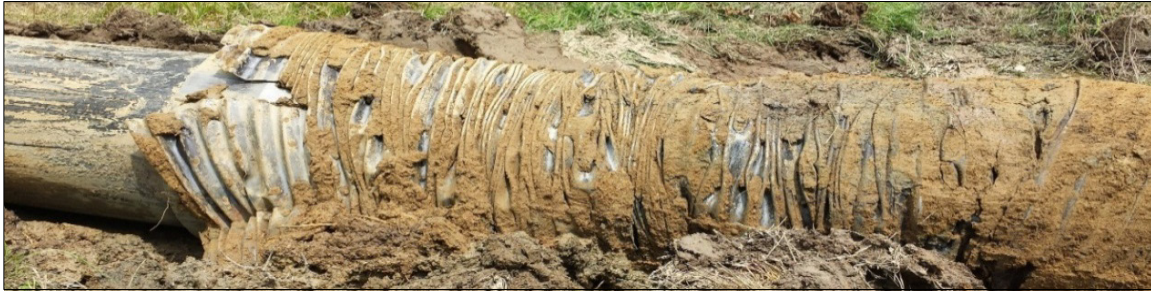
Figure 6: Folded CMP pushed out

The CMP was replaced successfully. However, The final few feet (estimated to be between 15 to 20 feet) of existing corrugated pipe folded onto the bursting head forming a ‘ball’ on the expander that was not cut, as it should be, by the bursting tool and was pulled into the pulling pit as shown in Figure 6. When bursting pipes longer than the 100ft that were burst in this case, the balling action may be very problematic.

Part of the existing corrugated pipe folded onto the bursting head forming a 'ball' on the expander and was pulled into the pulling pit. This was the final few feet (estimated to be between 10 to 20 feet) of the existing corrugated pipe which was not cut by the bursting head. There are two reasons that we can attribute to this:

1. The friction between the soil and final few feet of the corrugated pipe does not offer enough resistance to hold the pipe in place for the cutting edge to cut it. The path of least resistance is the movement of the final segment out the pulling pit, and
2. The existing CMP balls-up gradually over the drive and during the final few feet, the ridges have folded to the extent that the cutting edge is incapable of cutting the pipe. With increased force, the pipe is pulled out.

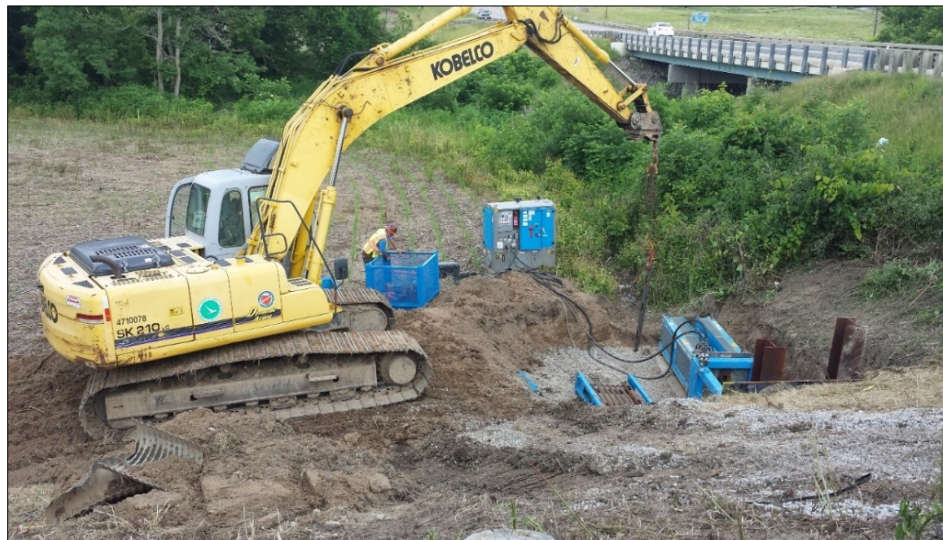
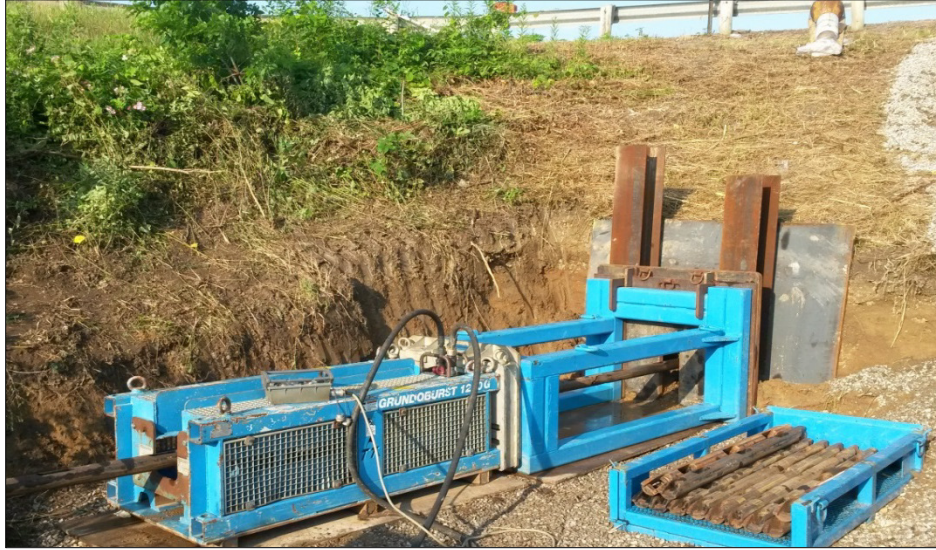
Figure 7a: System setup for static bursting

The static pipe bursting system was used to replace two culverts in ODOT’s District 5 and one in District 2. TT Technologies selected the Grundoburst 1250G to replace these three culverts with their details shown in Table 1. The setup for the static puling system is shown in Figures 7a and 7b.

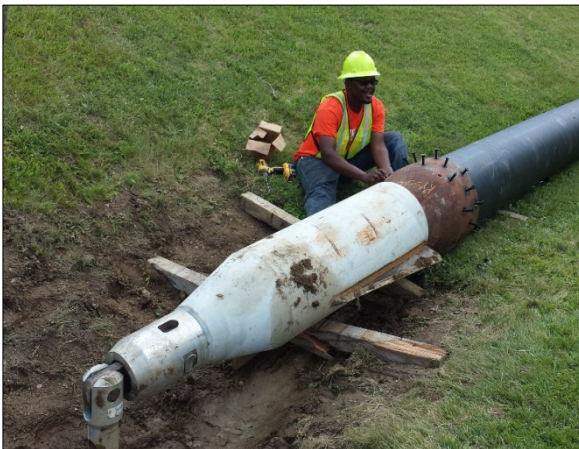
Figure 8: Bolting expander with bursting head on HDPE pipe

The bursting head, designed with a blade to cut the CMP ahead of the expander, was attached to the expander which was then bolted to the HDPE pipe as shown in Figure 8. Rods were driven through the CMP and connected to the bursting head to be pulled back, bursting the existing pipe while simultaneously installing the new HDPE pipe.

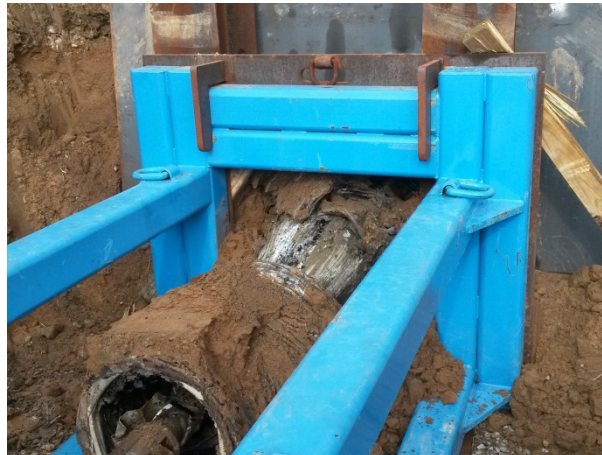
Figure 9: Folded CMP on bursting head

The duration of the second test in ODOT's district 5 was 12 hours 40 minutes with the actual bursting (installation) taking 35 minutes. The bursting rate was 0.4 minutes (24 seconds) per foot of pipe installed. The duration for the replacement in ODOT's district 2 was 14 hours 30 minutes with the actual bursting (installation) taking 30 minutes. The bursting rate was 0.25 minutes (15 seconds) per foot of pipe installed. And while all the bursts were successful, the last section of the existing CMP (about 10 to 15 feet) was always pushed out unburst as shown in Figure 9. This last section of the pipe would ball-up on the bursting head and get pushed out, unburst.

The balling effect of the CMP creates an overcut (bigger than the expander) around the installed pipe. This overcut is reasonably expected to get bigger for longer runs of installation. Pipe bursting is used successfully and routinely to replace pipes up to 500 feet in length. However, the CMP culverts tested were up to 120 feet long. From the field observations and conversations with the manufacturers, the research team reasonably concluded that pipe bursting systems can be used to burst similar CMP culverts up to 150 feet long. Further research is required to investigate the ability of the systems to replace longer runs of CMP culverts and to develop a more capable system to cut the CMP without excessive balling effect and overcut. It was also observed that the pneumatic burst took longer time than the static bursts.
