Tree/Sidewalk Conflicts: One Way to Save Trees

By: Megan Dettenmaier, USU Forestry Extension Educator,
and Michael R. Kuhns, USU Forestry Extension Specialist

This fact sheet describes a project undertaken by USU Forestry Extension and the City of Logan, Utah, to replace damaged sidewalks with flexible sidewalk panels made from 100% recycled plastic. These tiles allowed trees and most tree roots to remain intact. We explain the project methods, as well as the pros and cons of undertaking such a project. These materials and methods have the potential to change sidewalk and urban tree management practices.

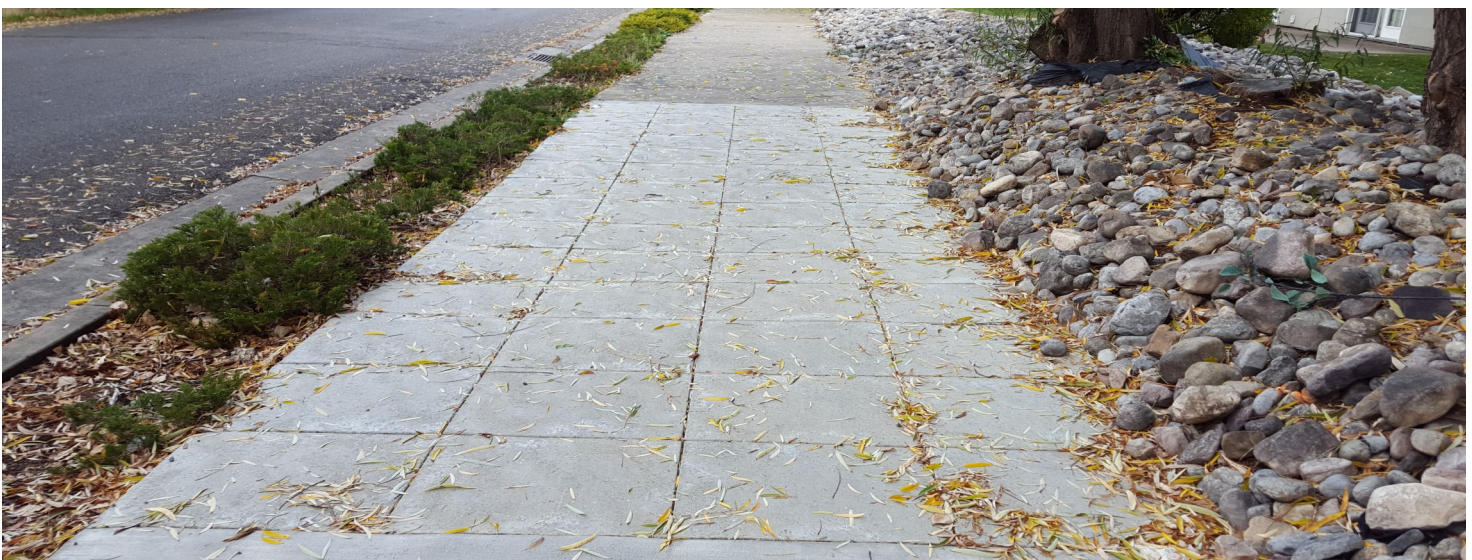
One sidewalk installation site in Logan located at 500 W Fairway Lane. Willow trees to the east were able to stay in place because the sidewalk tiles were used to replace the sidewalk that had been damaged by the tree roots.

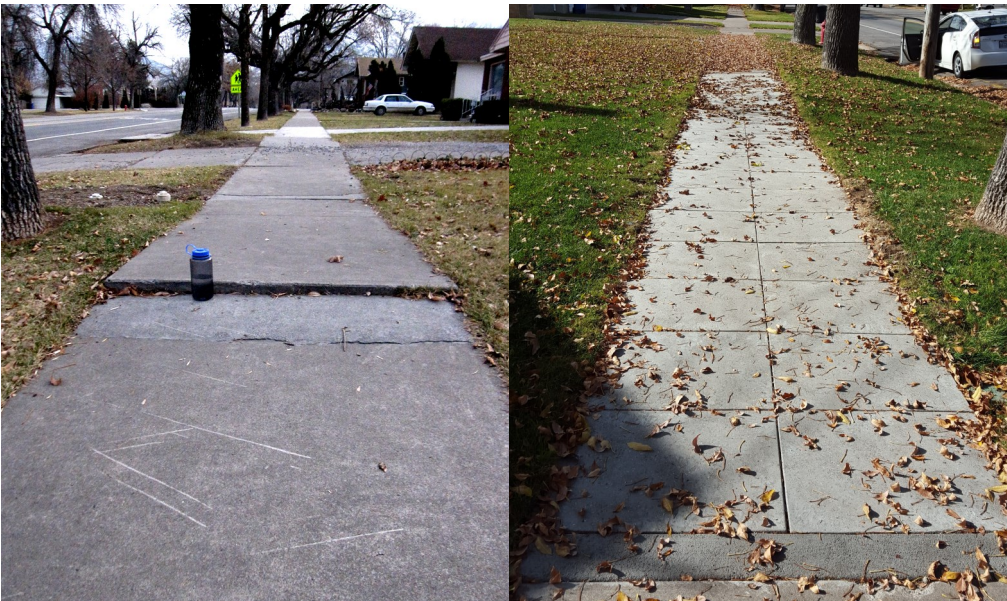
Before and after sidewalk located on the south side of 200 North between 400 and 500 West (444 W 200 N) in Logan. This sidewalk was excavated and sidewalk tiles were installed in fall 2015.

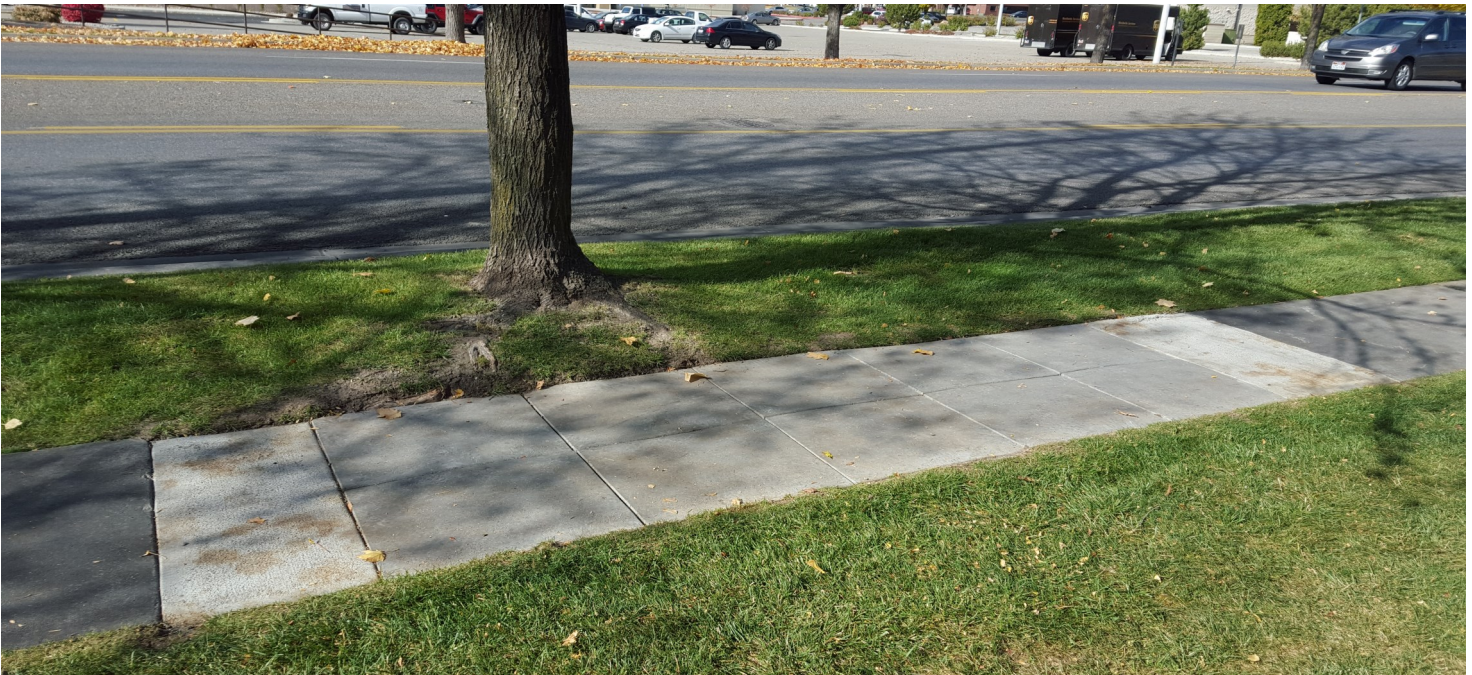
Another sidewalk installation site in Logan located at 1300 North 200 East. The close proximity of the Cache Valley Mall and Logan Pointe Apartments made this sidewalk a high priority for Logan City officials after the adjacent tree had buckled the old sidewalk in multiple places.
