Malaysia Airlines Flight 370: Evaluation of Key INMARSAT / ATSB Assumptions

***Stuart S. Yeh
University of Minnesota***

May 2016

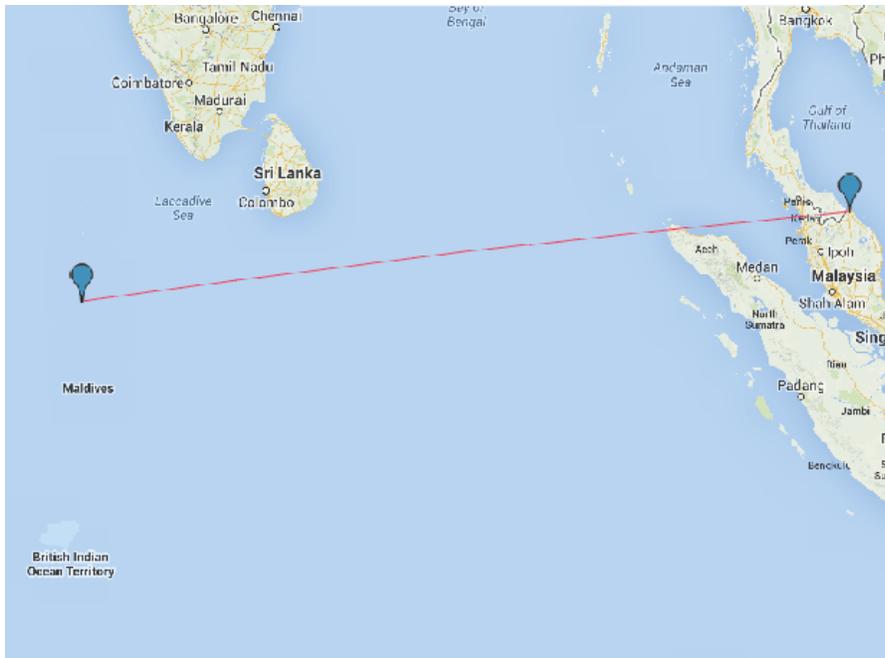
6:15 am local time is 9:15 am Malaysian time—8 hours and 34 minutes after takeoff, in other words, very near fuel exhaustion. If the report is accurate, MH 370 most likely crashed into the Indian Ocean southeast of Dhaal atoll in the Maldives (Figure 3). That is where the search should be concentrated.

Figure 3. Projected path of Malaysia Airlines 370 from Kota Bharu Malaysia to Dhaal Atoll in the Maldives

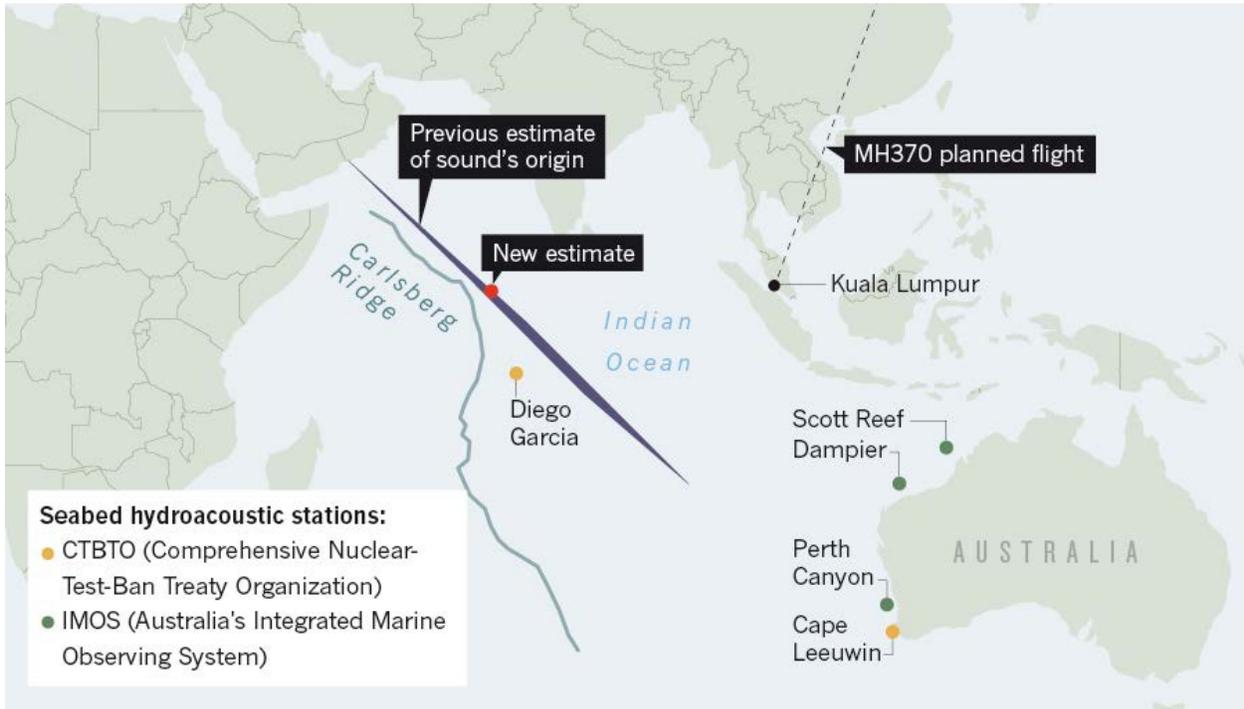
Australia. The new estimate places the source of the sound east of Carlsberg Ridge, remarkably close to the sighting of the unidentified aircraft over Dhaal atoll in the Maldives (Figure 4 and Figure 5).

Figure 4. Estimated geographic location of acoustic signal lies east of Carlsberg Ridge near Maldives

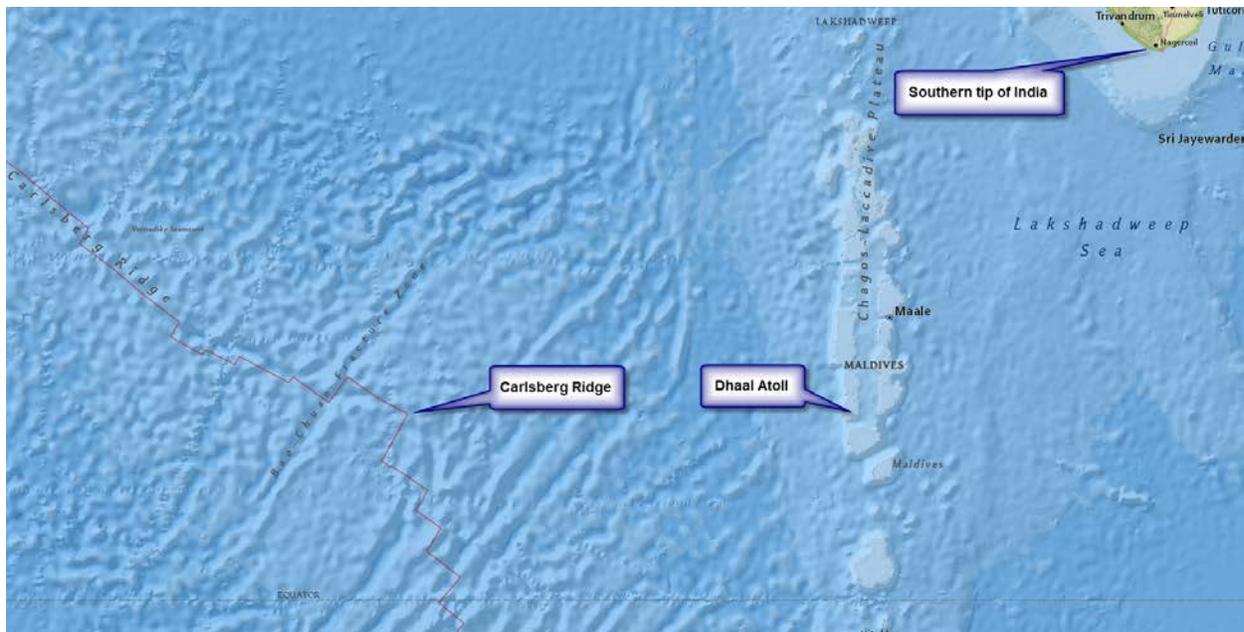
Figure 5. Dhaal atoll in the Maldives lies east of Carlsberg Ridge (see red line)

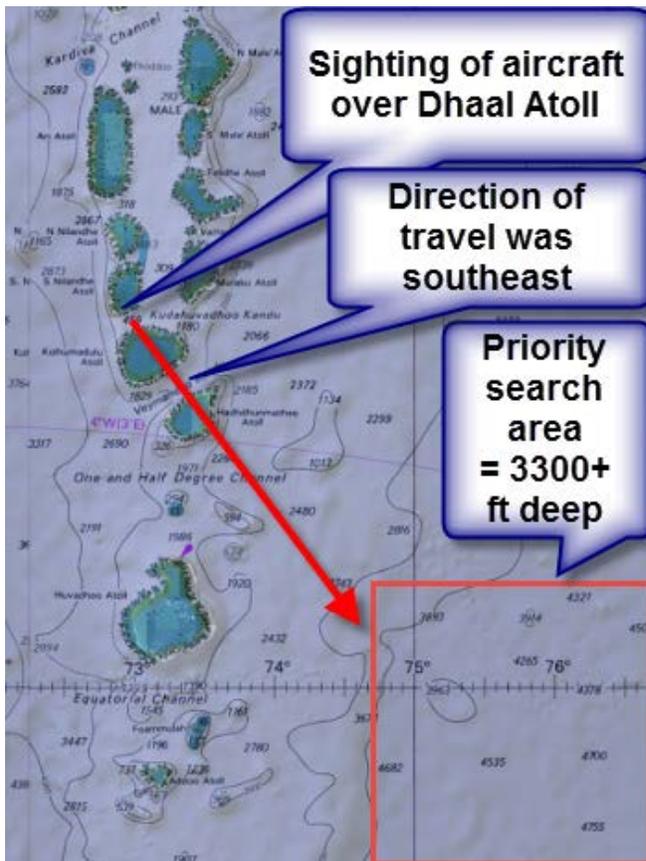
Alec Duncan, at Curtin University's Centre for Marine Science and Technology, stated that "if the sound [detected by two sets of underwater listening devices located off the west coast of Australia 20 minutes after the Dhaal atoll aircraft sighting on March 8] was generated by the implosion of some part of the aircraft as it sank ... at a depth of about 1000 meters, then the resulting sound would propagate effectively in the deep sound channel and could conceivably be detected at ranges of thousands of kilometers". This suggests that the search for MH370 should be concentrated in water that is a minimum of 1000 meters in depth. In sum, the priority search area should be water that is a minimum of 1000 meters in depth southeast of Dhaal atoll in the Maldives (Figure 6).

Figure 6. Priority search area southeast of Dhaal atoll in Maldives.

The current analysis suggests that search efforts should be redirected to the area southeast of Dhaal atoll in the Maldives. The aircraft was sighted 8 hours and 34 minutes after takeoff. Thus, it was very near fuel exhaustion and could not have traveled much further. If so, the search area would not be large. The towed underwater sonar device should be used to sweep this area in an effort to locate debris that presumably sank to the ocean floor. While some debris may have remained afloat and may eventually wash ashore on the east coast of Africa, the aircraft is a metal structure and, therefore, most of it would have sunk to the bottom of the ocean in the vicinity of the crash location, just as much of the debris from Air France 447 and the debris from TWA 800 was eventually located on the ocean floor.
