## Low-Cost Rural Surface Alternatives: Demonstration Project

Low-Cost Rural Surface Alternatives:  
Demonstration Project

tech transfer summary

A field demonstration project was conducted in Hamilton County, Iowa to compare the relative performance, durability, and costs of several stabilization methods for preventing or mitigating freeze-thaw damage to granular surfaced roads.

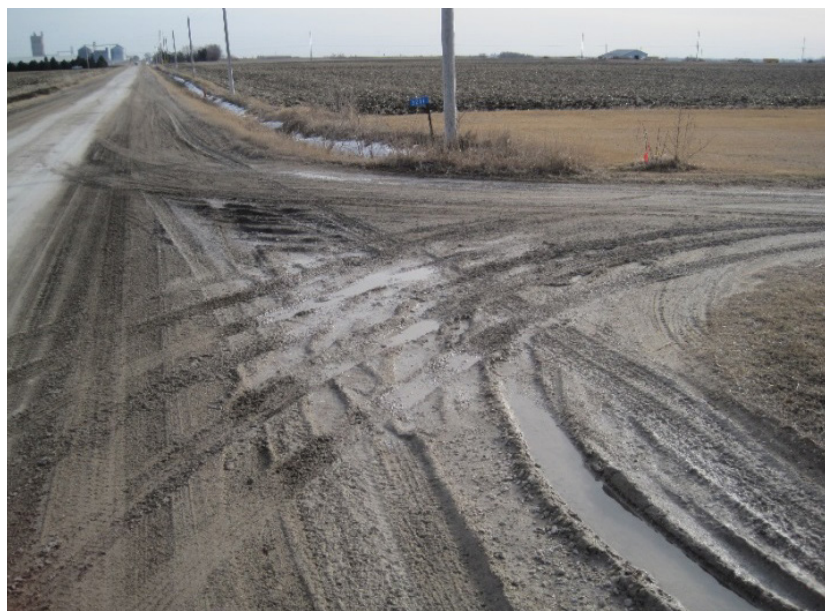
*Post-thawing conditions of selected road before stabilization*

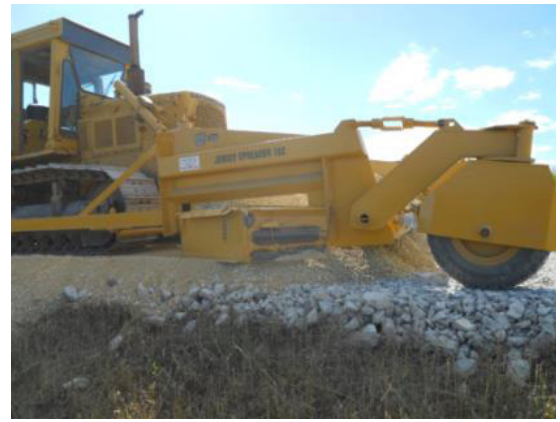
*An aggregate spreader was used to place the macadam base and surface course materials*

Most of the mechanical stabilization methods can be easily implemented by county secondary roads departments with existing crews and equipment. An aggregate spreader is needed for placing macadam stone.

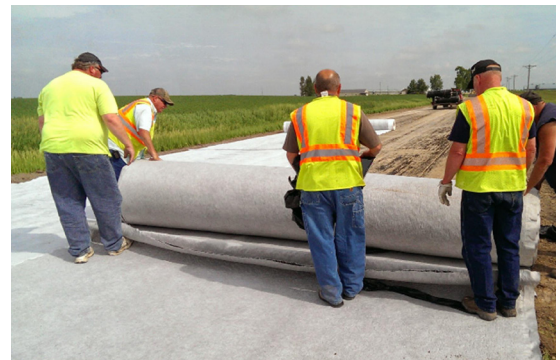
*A geocomposite drainage layer was placed at the aggregate-subgrade interface in Section 18*

- The geocomposite drainage layer increased the permeability of the surface material by two orders of magnitude, but some spots suffered significant rutting during thawing periods, which may require further study

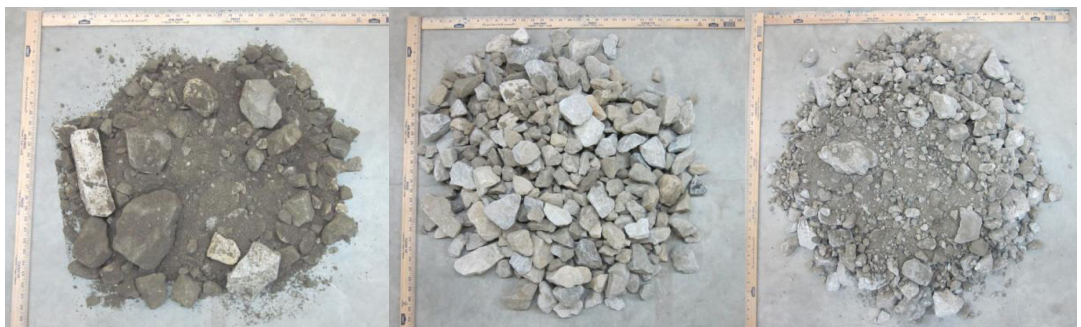
*Left to right:  
Dirty, clean, and  
recycled Portland  
cement concrete  
macadam materials*

- Three types of macadam (dirty, clean, and recycled Portland cement concrete/RPCC) were used as base materials in Sections 1 through 8 to improve stability and drainage. Nonwoven (NW) geotextile was embedded in some sections to provide separation and drainage. Chloride and bentonite surface treatment were also applied for dust control and stabilization.
- Aggregate columns were used as drainage basins in Sections 12 and 13 to prevent frost boils within the subgrade.
- Three chemical stabilizers (bentonite, class C fly ash, and cement) were used in Sections 15 through 17 to improve strength and stiffness of the surface course.
- Different geosynthetics were used in Sections 18 through 19B to improve subsurface drainage or strength of surface course.

- RPCC macadam is an economical alternative to clean or dirty macadam
- The stiffness of RPCC macadam increased one year after construction, possibly due to further hydration of the cement

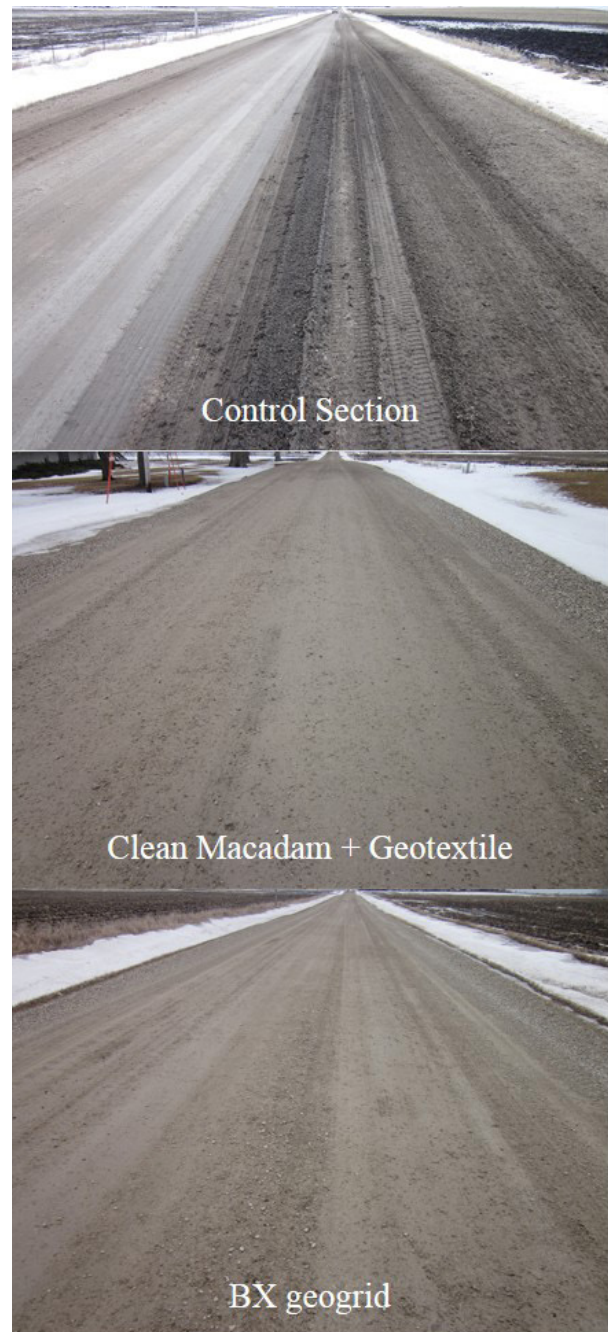
*Post-thawing surface conditions of three demonstration sections (March 11, 2014)*
